Battleship TEXAS Project Update

Report Number: 001
Report Period: February 1, 2013 through July 31, 2013
Purpose: Per the Programmatic Agreement (PA) among the Department of the Navy (Navy), the Texas Historical Commission (THC), Texas Parks and Wildlife Department (TPWD) and the Advisory Council on Historic Preservation (ACHP) concerning the Battleship Texas, TPWD is required every six months to submit a summary report detailing the work done on the ship pursuant to the terms of the PA. This document is intended to meet that requirement for the period indicated above.

Structural Repair of Battleship Texas

Photos and Exhibits Report 001

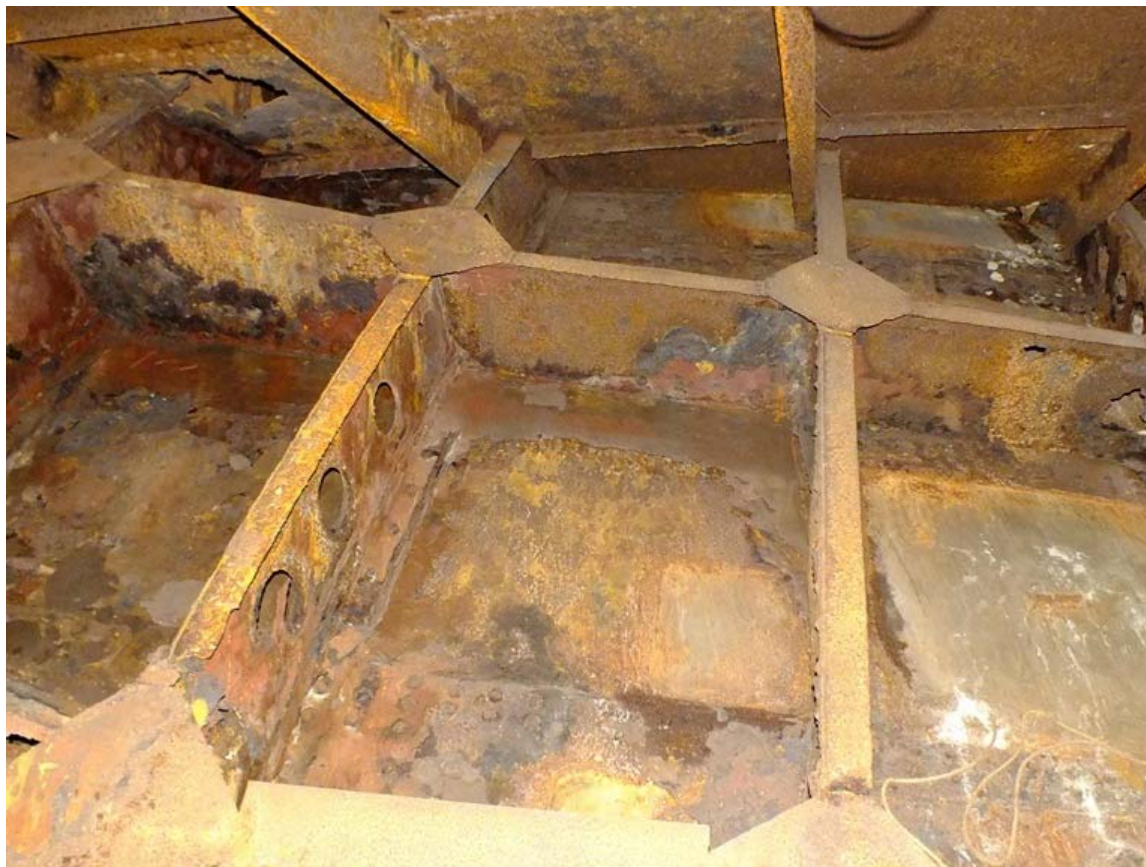
May 2013

Typical condition of frames in Trimming Tank D-12 prior to construction.
Port.

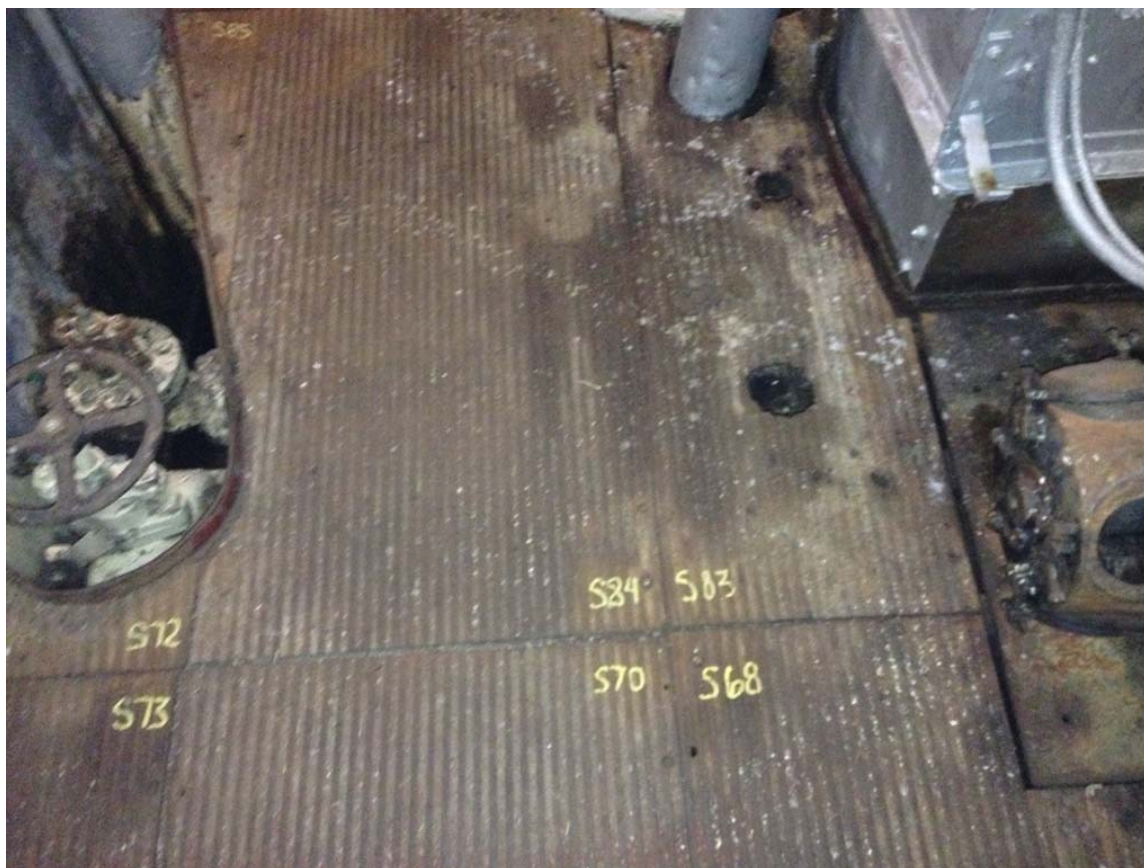
May 2013

Engine room deck plates prior to removal. Note painted identification numbers. CAD drawings made of each engine room plate layout, with identification numbers listed.

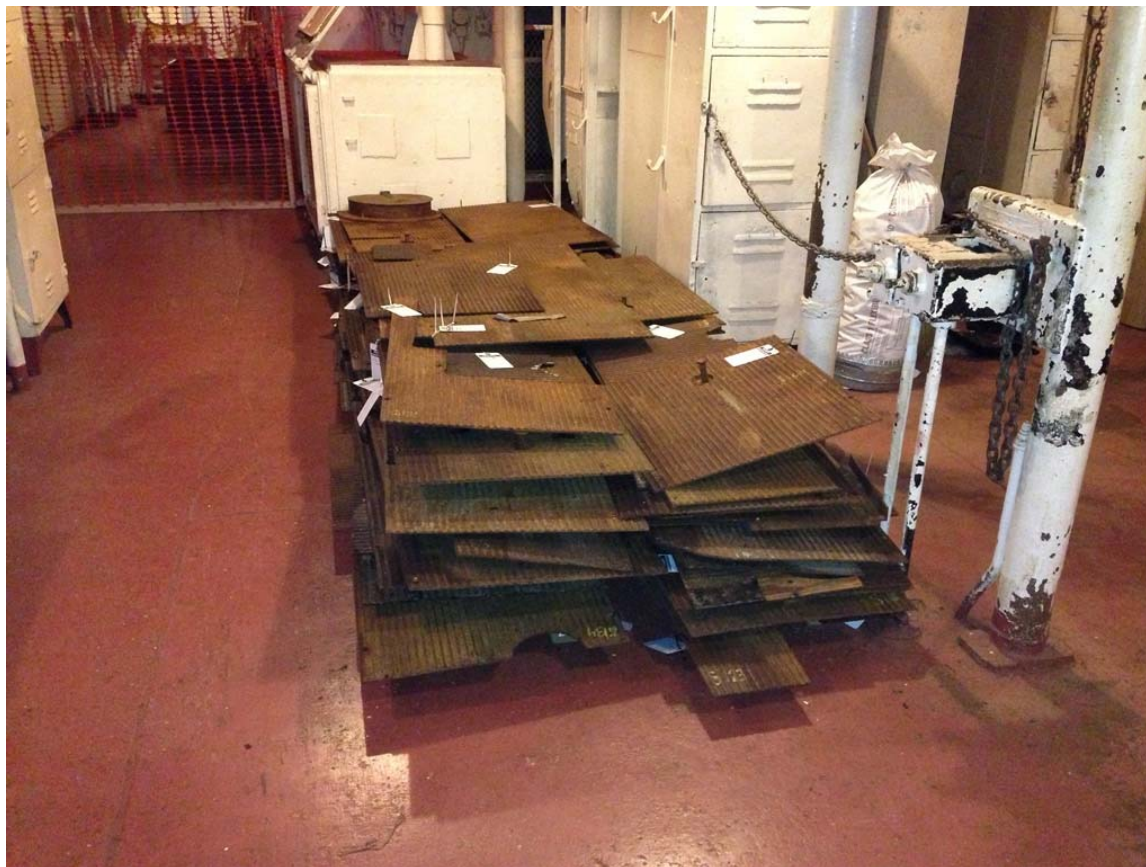
May 2013

Engine room deck plates stored in passageway after removal.

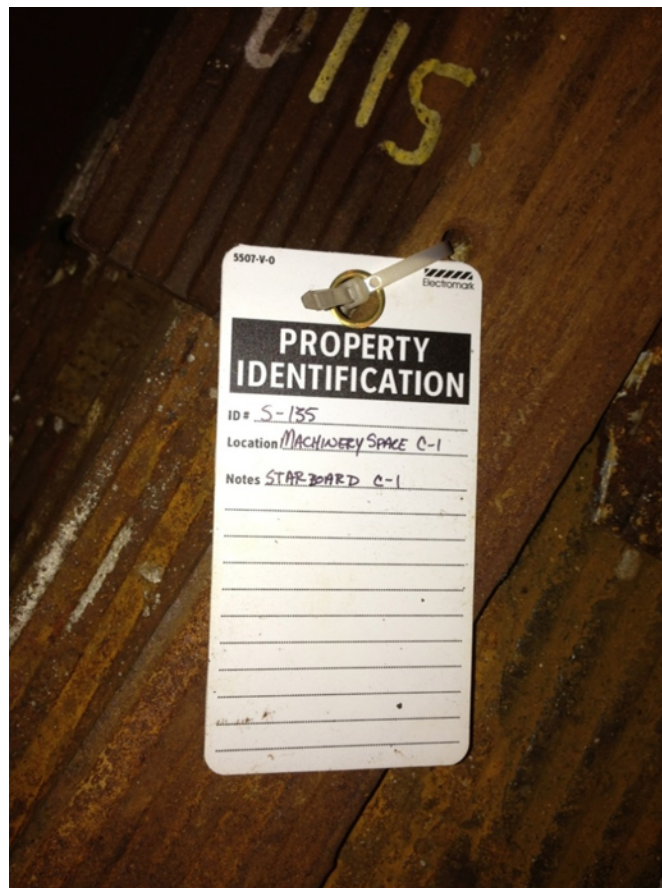
May 2013

Typical artifact identification tag (engine room deck plate shown).

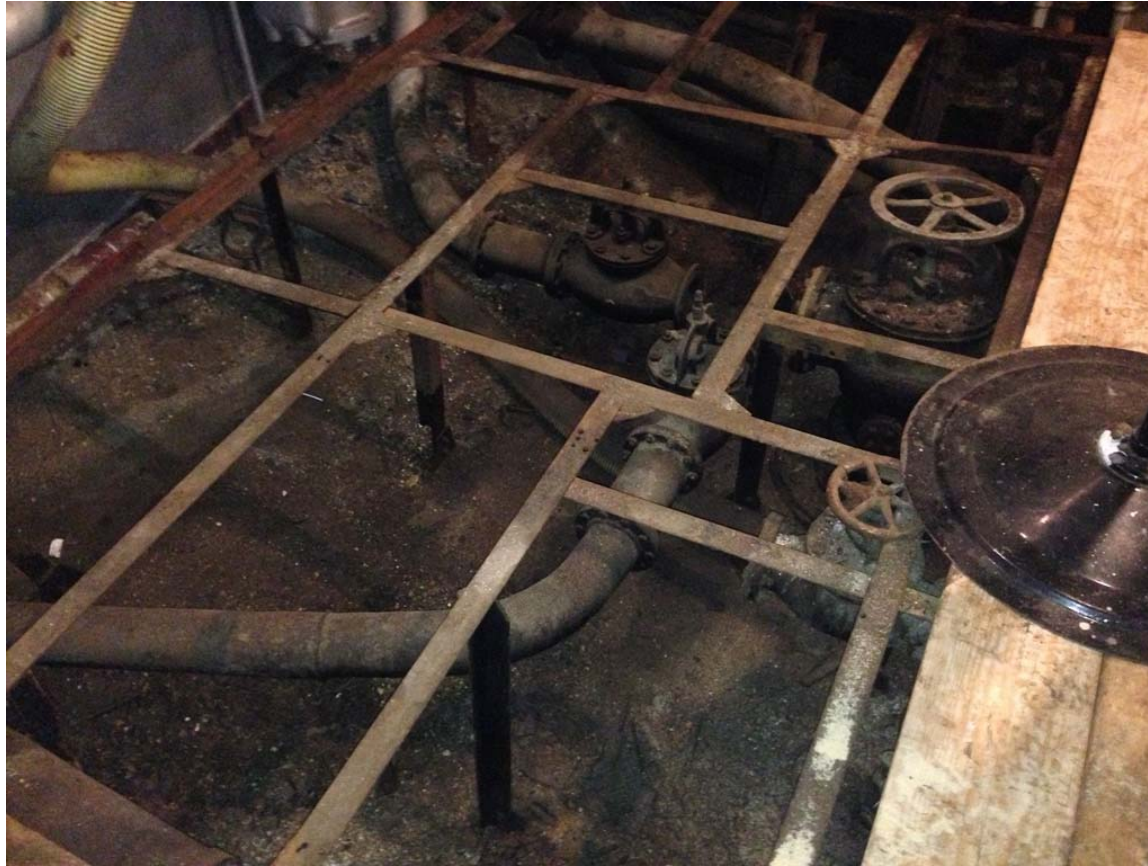
May 2013

Engine room deck plate supports after plate removal.

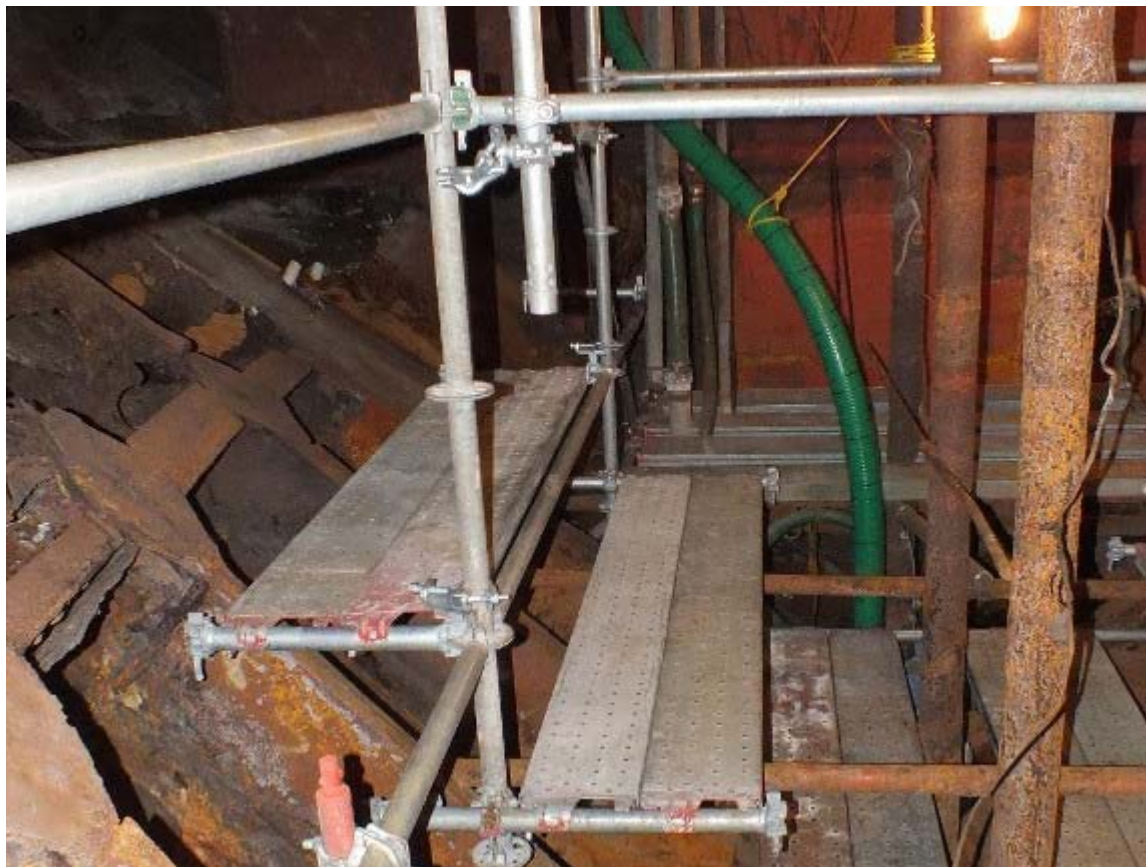
June 2013

Access scaffolding installed in Trimming Tank D-12.

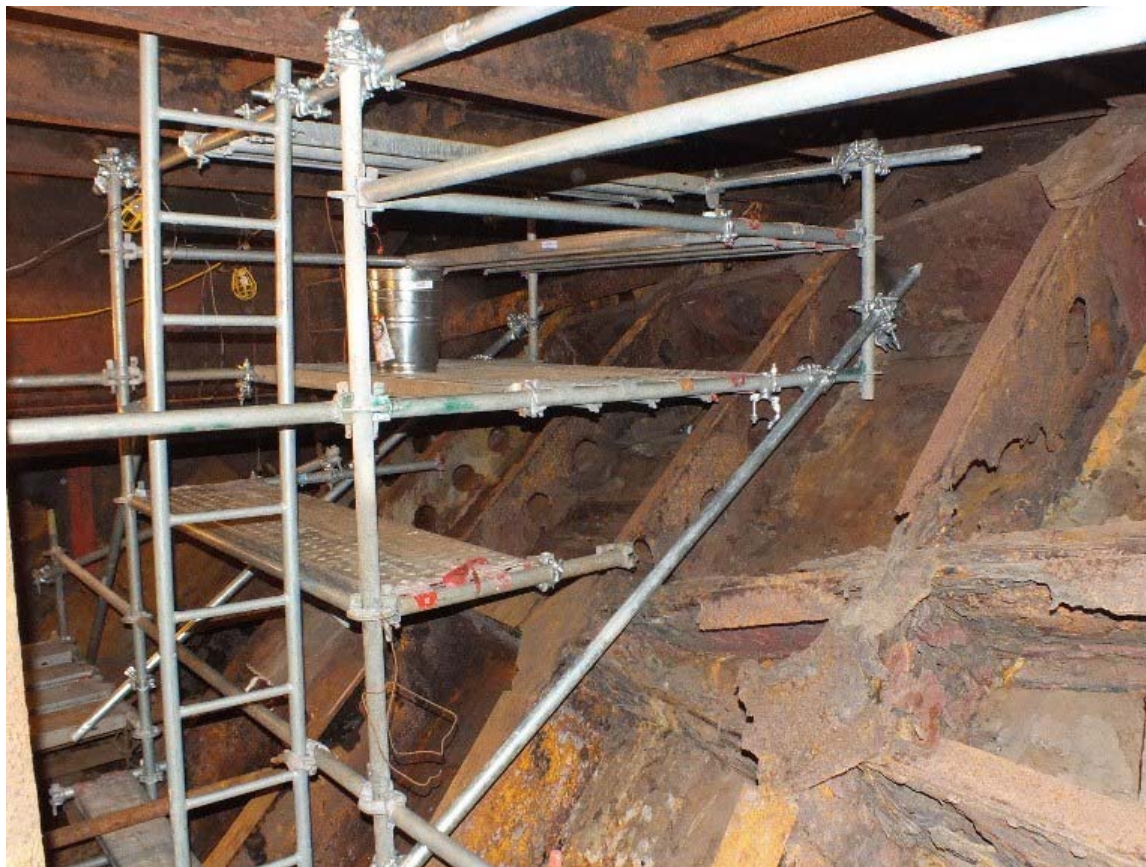
June 2013

Access scaffolding installed in Trimming Tank D-12.

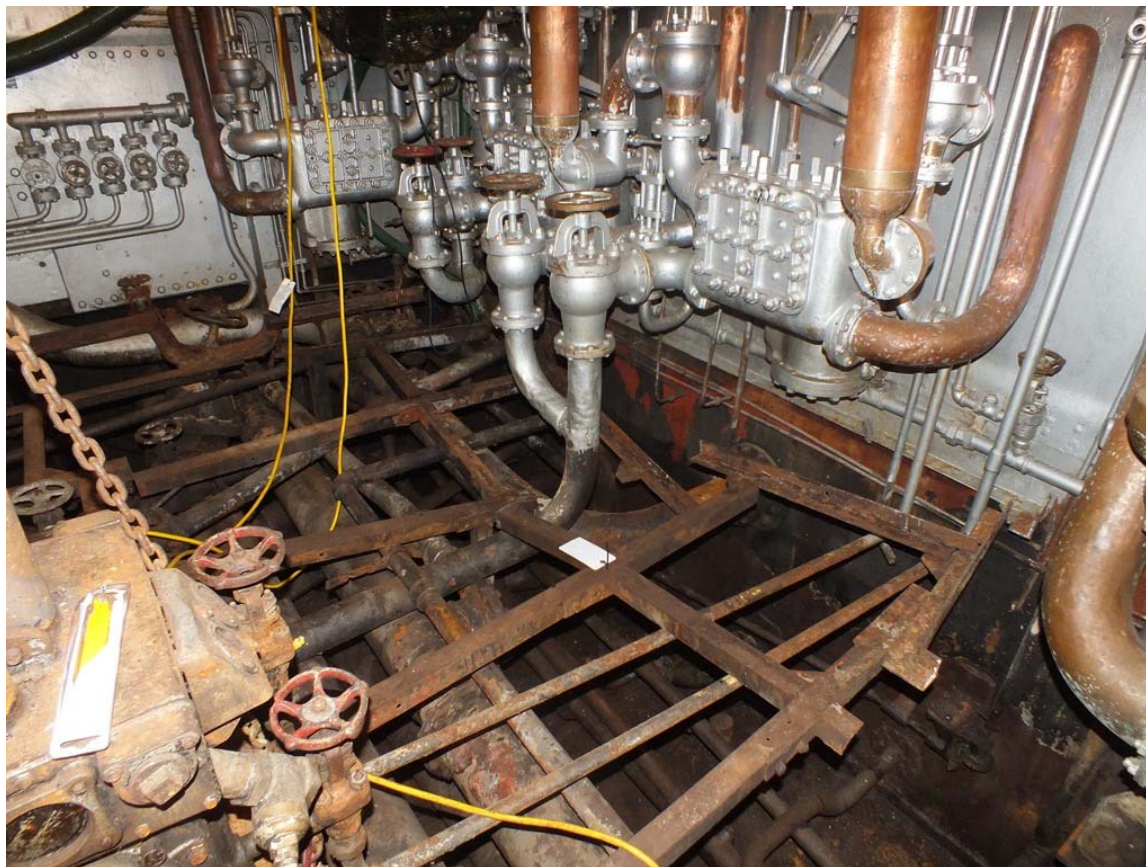
June 2013

Typical engine room piping configuration prior to removal.

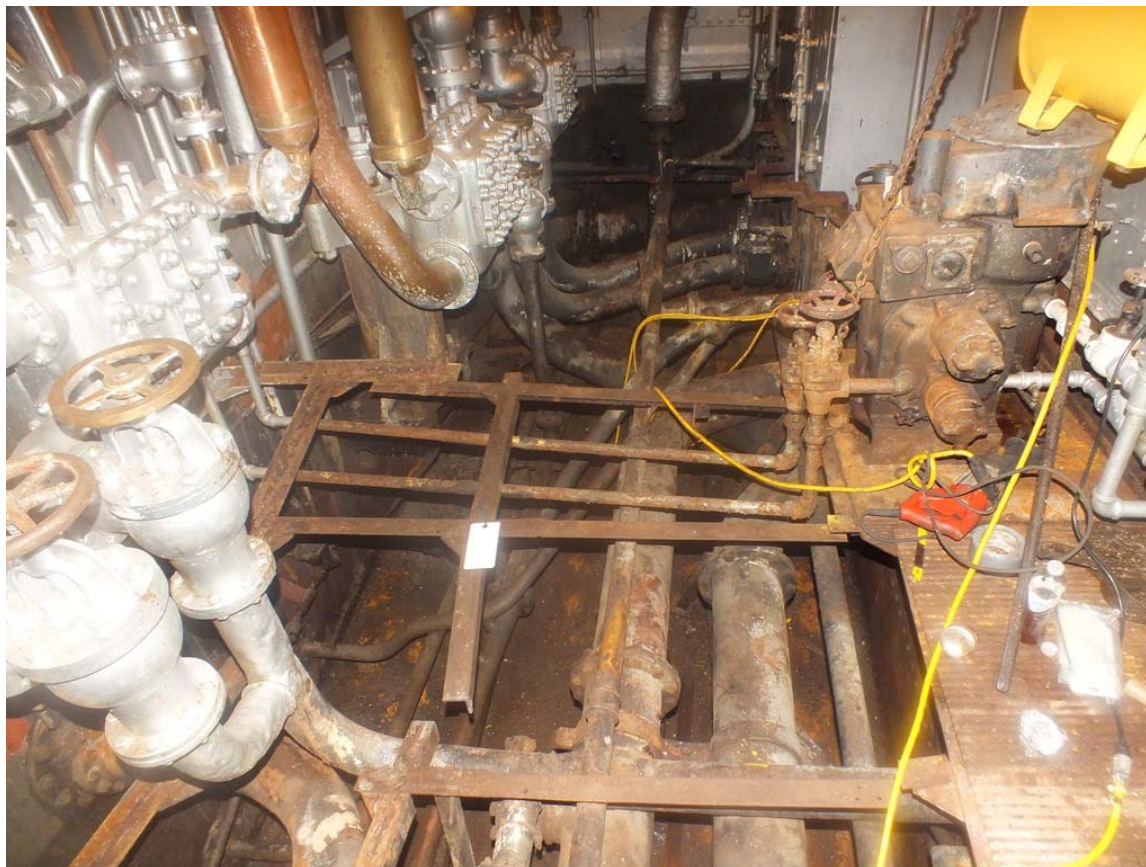
June 2013

Typical engine room piping configuration prior to removal.

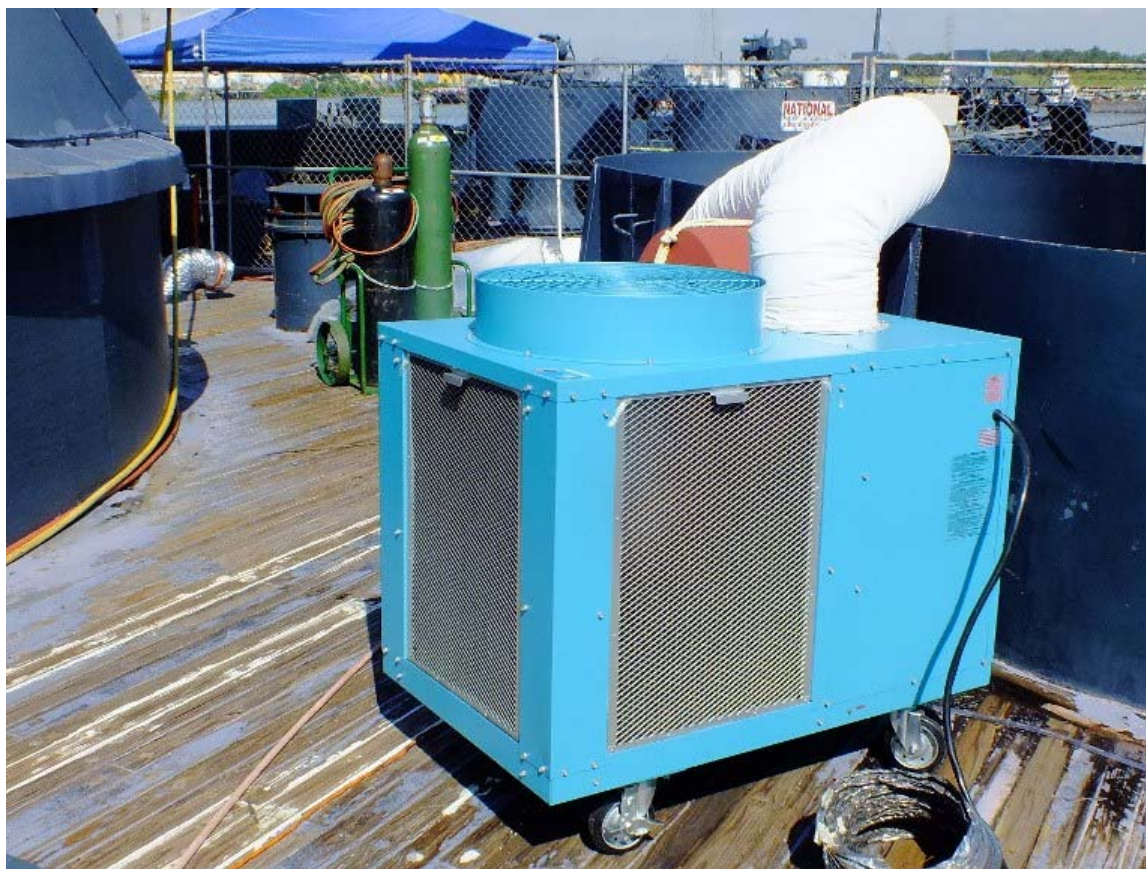
July 2013

Portable air conditioning unit staged on main deck. Note main deck chain link personnel barrier in background.

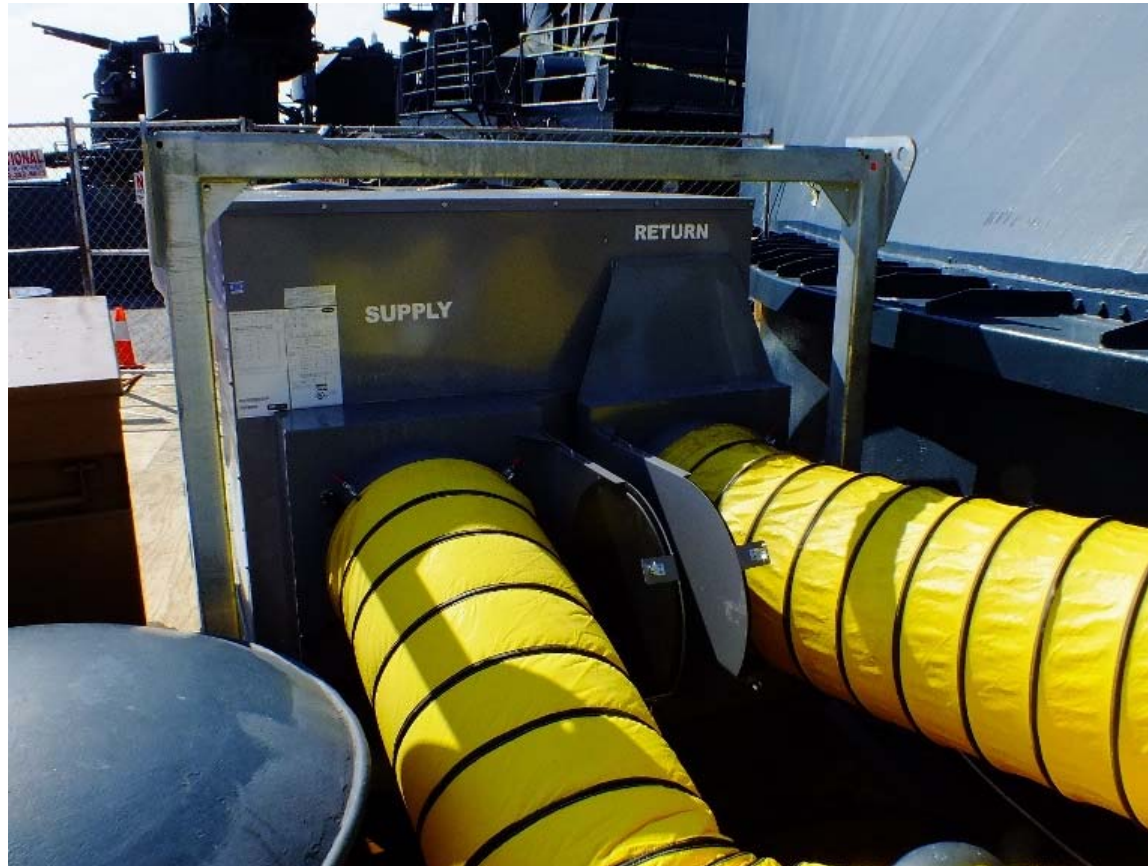
July 2013

Ventilation unit staged on main deck.

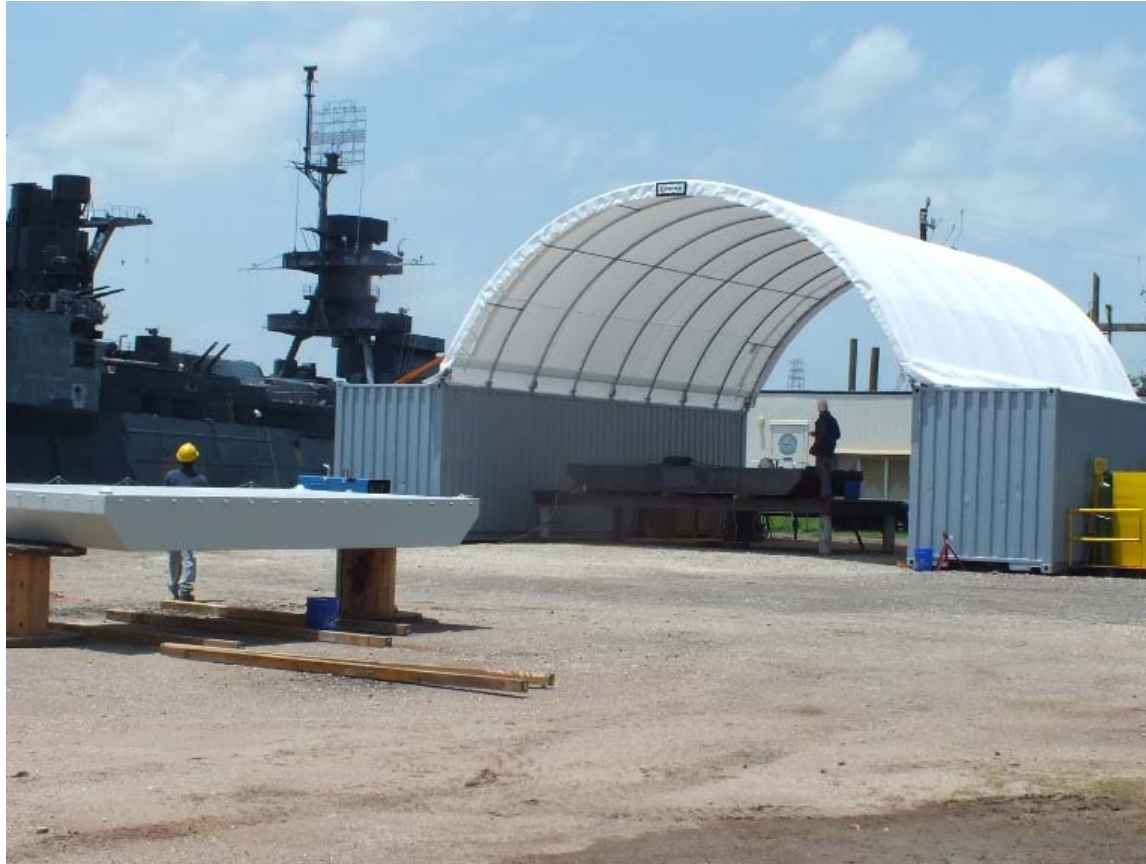
July 2013

Shade canopy erected in Staging Area.

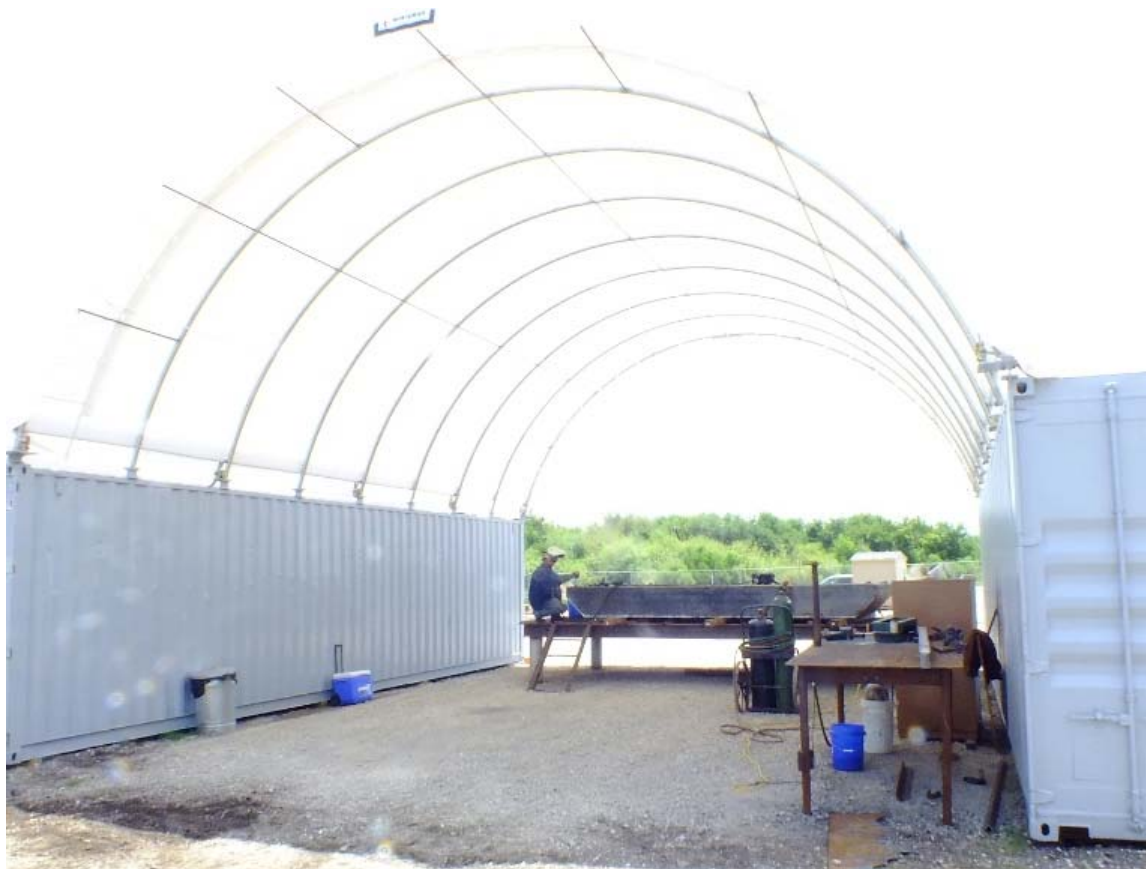
July 2013

Shade canopy erected in Staging Area.
